**General description and brief history (Pre-Treatment Station)**

This report refers to the survey of structural anomalies carried out at the WWTP, PRE-TREATMENT STATION building, located in Bairro da Munhava, with a view to their diagnosis and correction, and it is part of the scope of the to carry out a Master Plan and Preliminary Design for Rehabilitation and Expansion of the Sanitation System of the City of Beira, assigned to the consortium PLANET SEURECA VEOLIA, currently in progress..

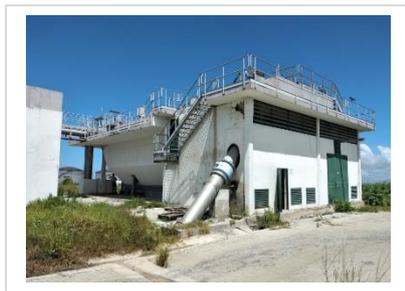
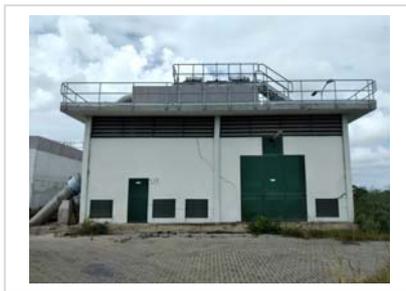
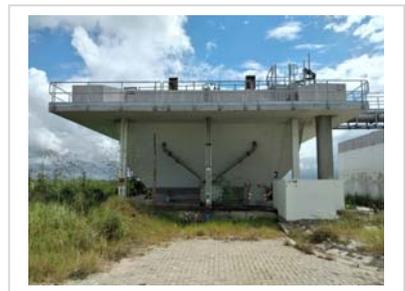
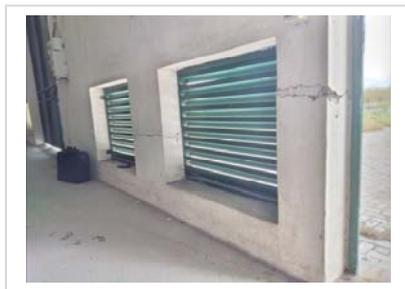
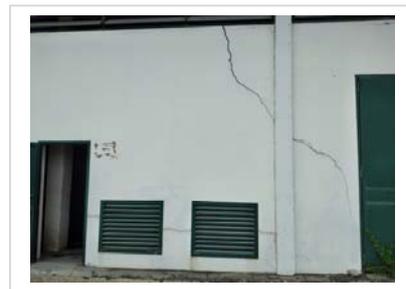
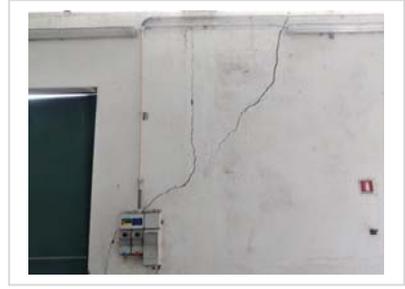
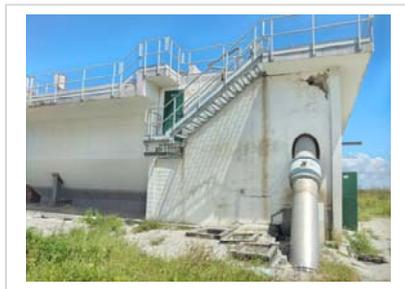
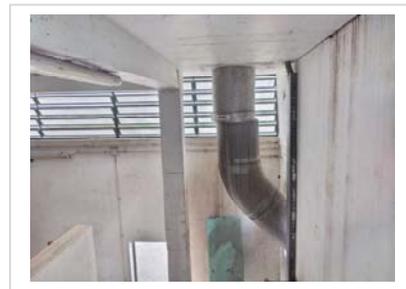
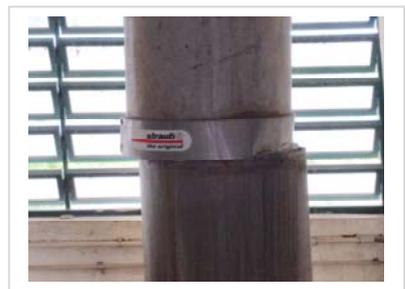
This building has evident rupture defects in various parts, such as floor slab which connects the foundation pile heads, and the superstructure with a greater incidence by the inlet of the feed pipe from EE4 pumping station. The photos below show some of the most affected parts of the building.

The superstructure of the Pre-Treatment Station, namely, the walls of the tanks, present micro-cracks in some points, which can, however, be stopped by waterproofing, after the foundations have stabilized. In the first sample of photographs (page 1, last photo) one of the points with these characteristics is presented.

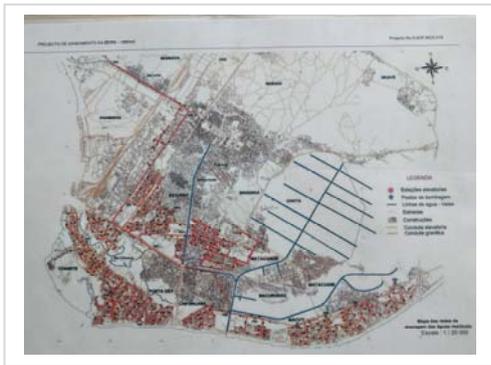
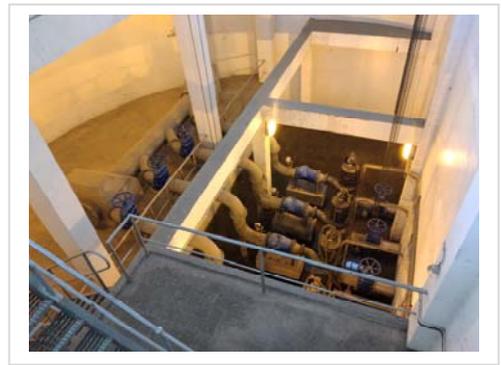
The WWTP started operating in 2010, having been operational until March 2019, when Cyclone IDAI destroyed several sanitation system infrastructures in general, including the EE4 Pumping Station (photo below), located inside the WWTP site, where there was a rupture of the inlet pipe that is at 6m depth, with the water table at about 1.5m deep, depending on the climatic season.

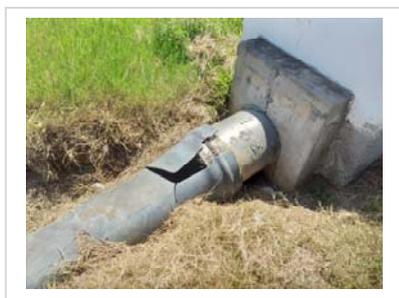
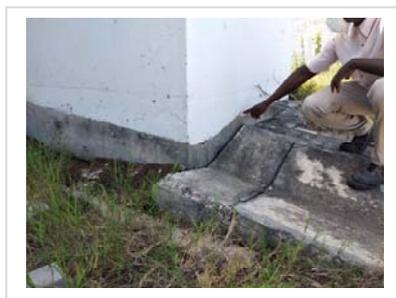
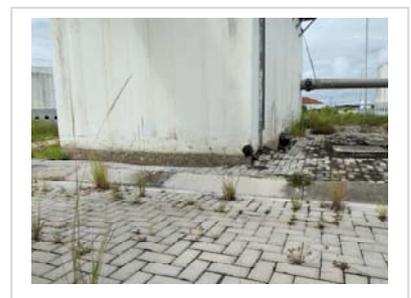
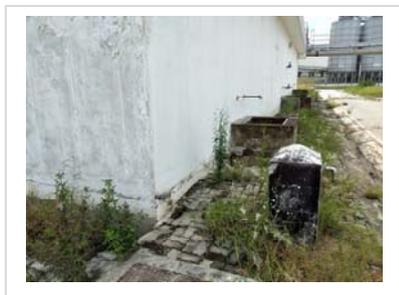
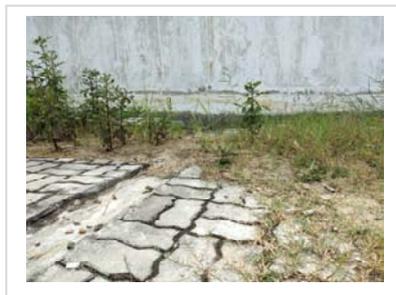
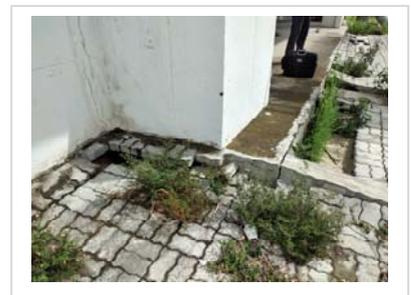
The fact that only the structures are supported by piles, and most of the pipes and connection pipes have been buried in ditches, and are based on a sub-base of the existing soils, with a layer of about 9 m of soft clays, added to the weight of the landfill, the vehicles movement, and the weight of the pipes that work in forced flow (section filled by pumping) contributed to the acceleration of the settlements in the circulation areas, as opposed to the structures supported on piles. This phenomenon is visible in the perimeter of most structures and valve chambers, as can be seen in the following photos:

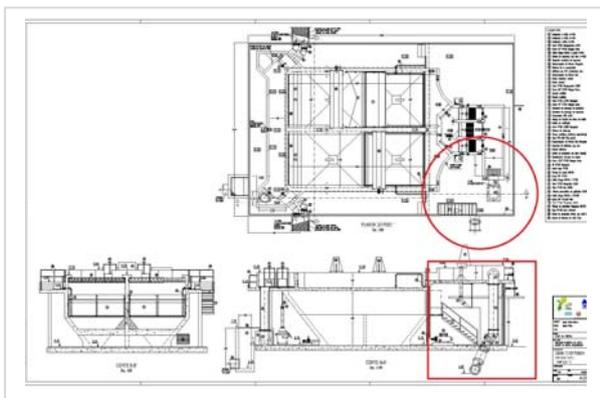
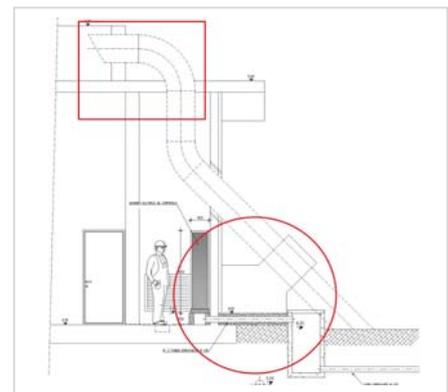
An expedited measurement on site, during the survey carried out with the support of the personnel assigned to the WWTP, using a level hose, shows that the area of the building where the main pipe from EE4 is unloaded, on the side where the stairs are located, settled about 32 cm, in relation to the diagonally opposite area.

Despite the progression of the settlements, the Pre-Treatment function has been carried out for about 10 years, only interrupted due to the rupture of the pipe next to the building, as shown in the images.

These ruptures frequently occurred as a result of the rigid pipe, without flexible joints, not being able to resist the efforts caused by the continuous and distinct settlements of the pipe and supports, as well as the building as a whole. The repairs to the pipeline carried out were aimed at restoring the existing situation, thus renewing the rupture-repair cycle.

In addition to the reinforcement of the structure, it is also recommended that the support for the discharge of the main pipe, with connection to the EE4, be disconnected (independent supports) from the building structure, and, that flexible supports are introduced to absorb the stress transmitted by the flow under pressure and hydraulic phenomena resulting from the interruption-start of the lifting pumps.

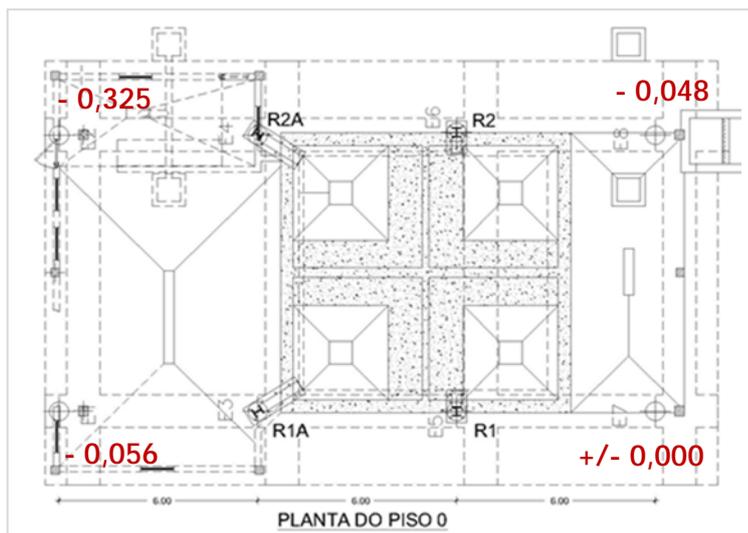
In order to assess the existing unevenness resulting from the differential settlements of the structure, with the support of the head of the WWTP, Mr. Cláudio and auxiliary staff, a survey was made of the levels of the pavement of Floor 0. As can be seen in the figure shown next, there is a visible slope in the direction of the corner of the pipe inlet. The unevenness occurs in the direction of the 3 corners of the pavement, being significantly more accentuated precisely in the corner where the aforementioned pipe is discharged, with a difference of 0.325 m in relation to the diagonally opposite corner, taking the reference point as +/- 0,00.

In a way, these movements of the structure can be considered as being a global rotation of the structure, having clearly set (-) in the area of the discharge corner of the pipe (-0.325), showing some signs of superelevation (+) in the area of the corner assumed as a reference (+/- 0.000), located diagonally in the opposite corner.

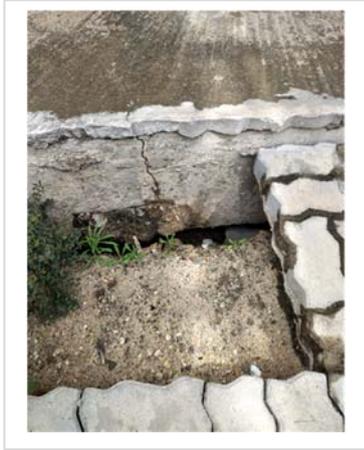
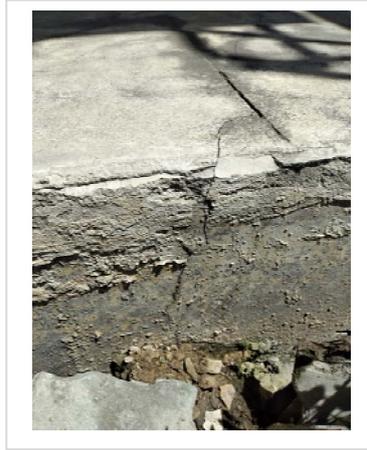
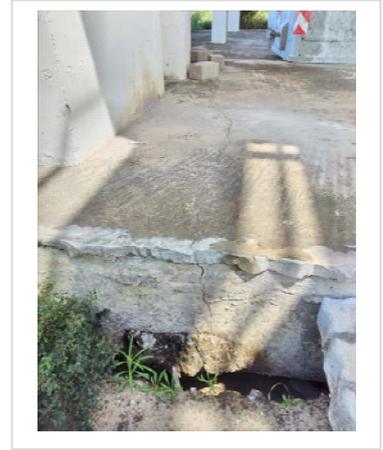
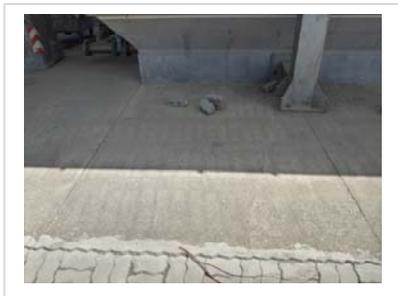
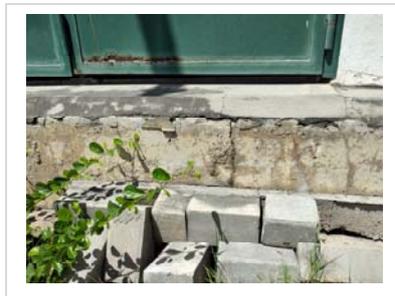
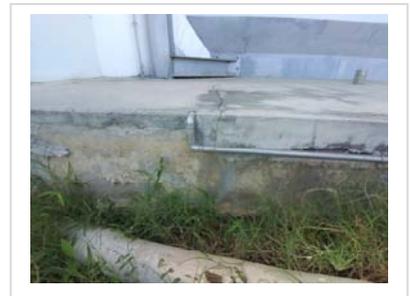
The aforementioned unevenness is due to the combination of two factors: the global settlement and rotation of the structure and cracks at different points of the pavement slab and the interconnection of foundation pile cups, as can be seen in the photos below.

1. The occurrence of cracks on the pavement slab, at various points and at different periods, starting at the beginning of the activity and testing phase of the equipment seems likely, and according to witnesses it will have had occurred. With this weakened equilibrium element (slab), which should offer greater resistance to the reaction of the different piles, the probability of the occurrence of differential settlements is high, as it turns out to be the case.

These points of cracks in the slab, with the acting of the self-weights and overloads, on the one hand, and on the other, the differential settlement of some of the most loaded piles, allowed the slab to rotate, resembling an inflection point, resulting in added unevenness.

The reinforcement of the foundations and the connecting elements of the piles, at the level of the pile cups, currently performed by the pavement slab, becomes essential, given the advanced status of collapse in which the structure is.
