**General description and brief history (Pre-Treatment Station)**

This report refers to the survey of structural anomalies carried out at the WWTP, PRE-TREATMENT STATION building, located in Bairro da Munhava, with a view to their diagnosis and correction, and it is part of the scope of the to carry out a Master Plan and Preliminary Design for Rehabilitation and Expansion of the Sanitation System of the City of Beira, assigned to the consortium PLANET SEURECA VEOLIA, currently in progress..

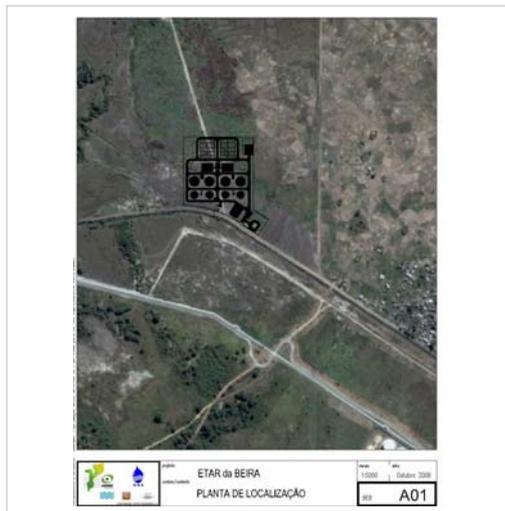
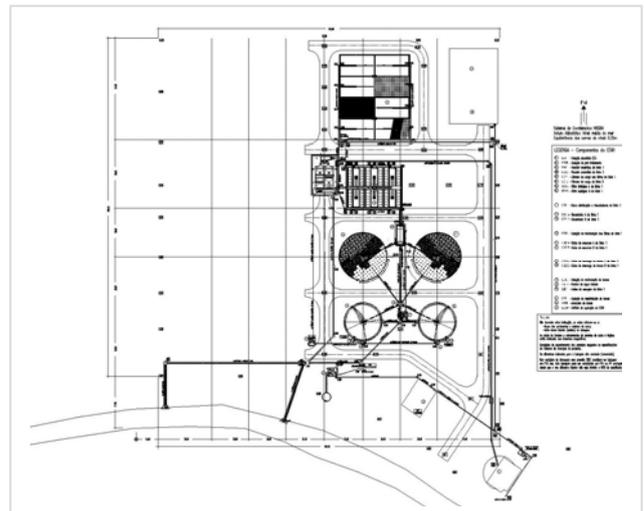
The WWTP was built in the estuary of the Pungue River, north of the industrial zone of the Beira Port, which had previously been used as the city's main solid waste dumping site since the beginning of the 70s..

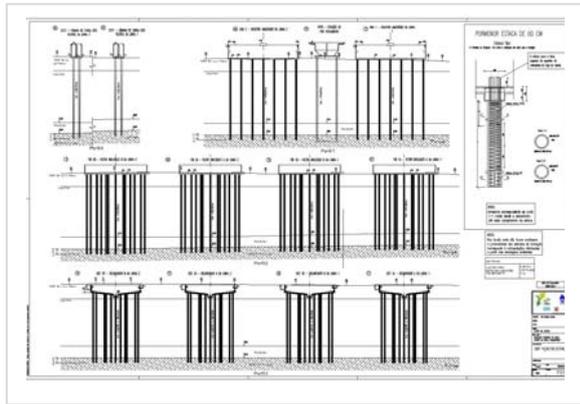
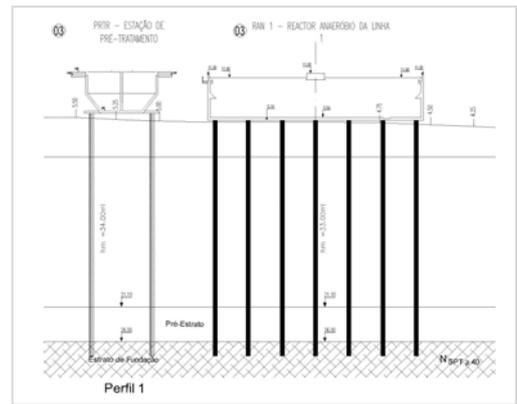
According to the tests and geotechnical studies that guided and preceded the construction, the subsoil layer with sufficient consistency and compaction state to support the WWTP structures, is about 25m deep, with the upper layers being composed of soft clays, coarse to medium sands mixed with silts and clay in small quantities.

A general landfill was carried out with imported selected soils, over the areas of implantation and circulation of the WWTP, estimated at about 1.0m-1.5m in thickness.

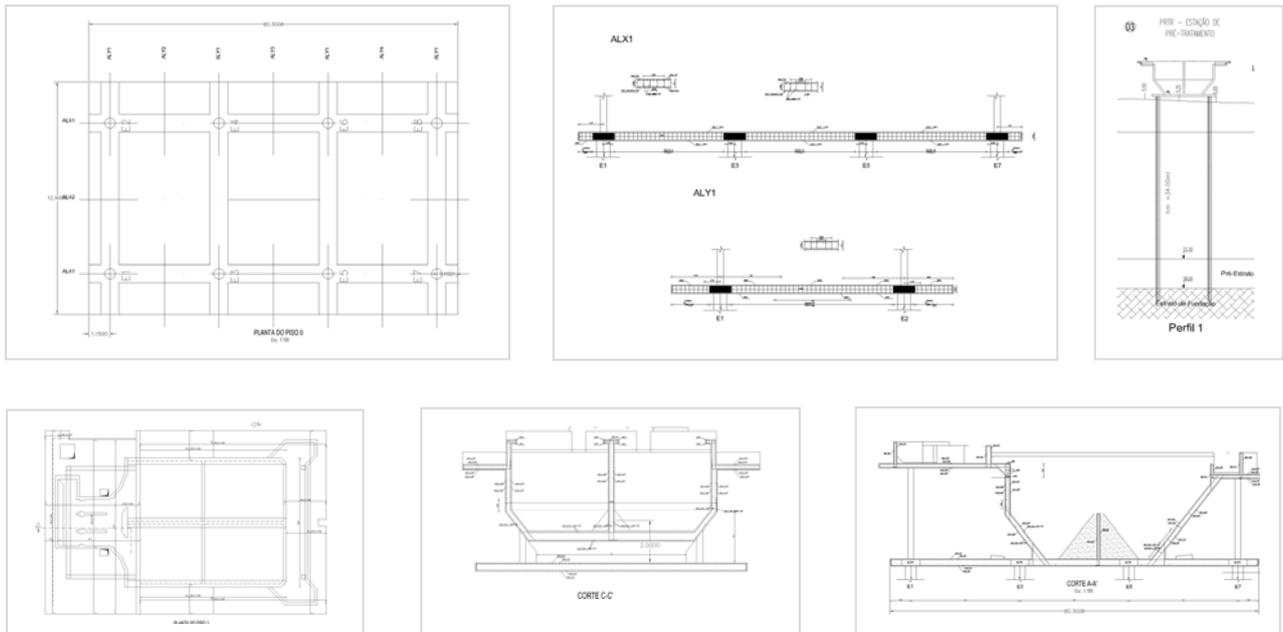
The Pre-Treatment building, rests on a set of 8 reinforced concrete piles with approximately 34.9m length and 0.60m diameter, interconnected by a pavement slab with an area of 20.30x12.90m<sup>2</sup> and 0.40m thick, reinforced with beams embedded inside. The piles discharge (tip resistance) in a layer of medium and fine sand of low compactness. In the design, the lateral resistance of the pile was not considered due to the clayey nature of part of the lower strata, as classified after to the surveys and geological studies that preceded the design of construction works.

The reinforcement of the foundations and the connecting elements of the piles, at the level of the pile cups, currently performed by the pavement slab, becomes essential, given the advanced status of collapse in which the structure is.
